EXHIBIT R

Degradation of polypropylene in the human eye: A sem-study

W.L. JONGEBLOED1 and J.F.G. WORST2

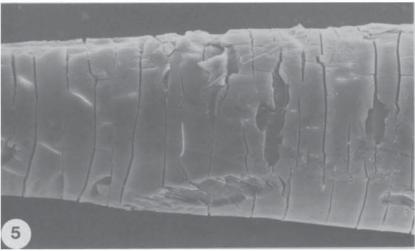
Figures 2 and 3 represent parts of the left side of the suture, cracks perpendicular to the longitudinal axis of the suture are visible. Lumps of the surface layer are nearly detached or are already missing (arrows). Note also the irregularity of the diameter of the suture in both pictures.

Figure 2. Part of left side of suture of Figure 1, showing cracks in surface layer and missing part of surface layer (arrows); note irregular diameter. Magn. $225 \times$.

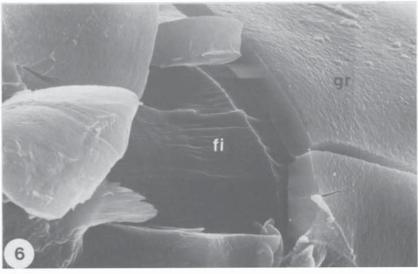
Figure 3. Part of left side of suture of Figure 1, showing cracks in surface layer and nearly detached lump of surface layer (arrow); note somewhat twisted shape of suture. Magn. $325 \times$.

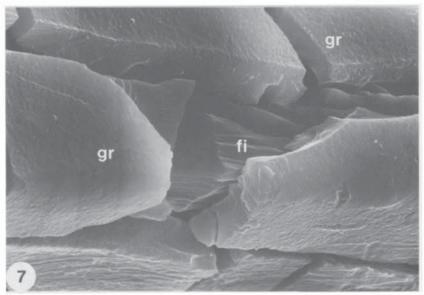
Figures 4 and 5 also represent parts of the left side of the used suture of Figure 1. The cracking of the surface layer is very obvious in Figure 4; almost the complete surface layer has been split off from the underlying layer. The outer surface of the lumps is covered with a thin layer of probably organic material with a slightly granular appearance (Figure 4). Closer to the central part of the suture (the part which was not in direct contact with the tissue) the disintegration of the polypropylene appears to be considerably less extensive. Figure 5 represents a part of the suture left of the centre, the cracks in the surface layer are already present and the diameter decreases towards the left side of the suture.

Figure 4. Part of left side of suture of Figure 1 showing completely disintegrated surface layer, large lumps nearly detached. Magn. $1000 \times$.

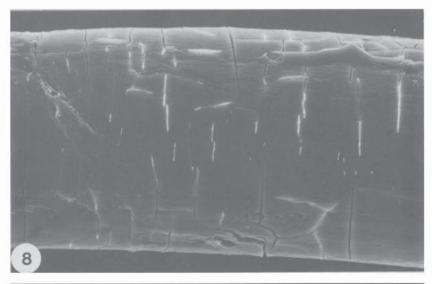
Figure 5. Part of left side of suture of Figure 1, close to central part of suture. Surface less attacked; note decreasing diameter towards left side. Magn. $300 \times$.

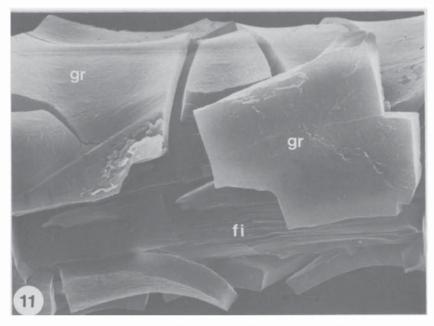
Figure 11 shows the destruction of the polypropylene in a rather dramatic way; the complete surface layer has broken into pieces, exposing the subsurface layer. The outside layer is covered with some deposits, mainly of a granular nature.

Figure 11. Part of right side of suture of Figure 1 showing almost complete degradation of surface layer, large lumps have detached exposing subsurface layer with fibrillar character (fi). Note granular deposit on lumps (gr). Magn. $975 \times$.

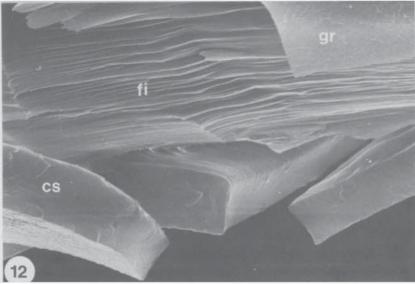
The subsurface layer is observable in more detail in Figure 12 (detail of Figure 11); the fibrillar character of this layer is clearly visible, while the splitting of the surface layer is noticeable, particularly at the cross-sections of the split-off lumps in the lower part of the picture.

Figure 12. Detail of Figure 11 showing subsurface layer (fi) and split-off lumps of surface layer in more detail (cs). Magn. $2500 \times$.

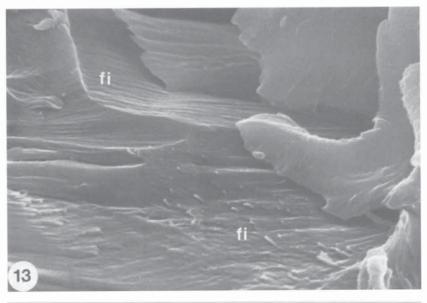
The fibrillar character of the subsurface layer, and the irregular splitting of the surface layer from the underlying layer as the result of a chemical change in the surface layer, are shown in more detail in Figure 13.

Figure 13. High magnification of subsurface layer after detachment of surface layer; note irregular splitting effect due to chemical change in polypropylene. Fibrillar character (fi) of subsurface layer clearly observable. Magn. $5000 \times$.
